AVIATION INVESTIGATION REPORT

A01Q0053

LOSS OF SEPARATION

NAV CANADA
MONTRÉAL AREA CONTROL CENTRE
MASSENA, NEW YORK
27 MARCH 2001

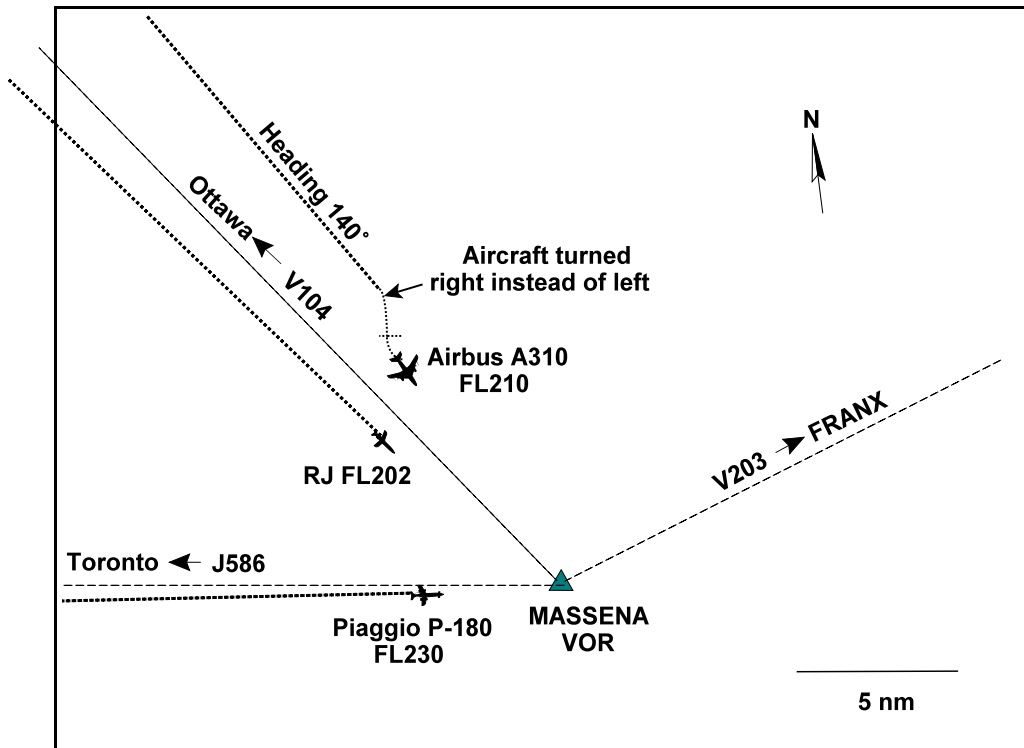
The captain misheard the clearance from the Valley controller and requested confirmation that the clearance was to climb to FL300. As well, he repeated what he thought was the instruction to turn right to a heading of 170° (30° right). The Airbus began a right turn but then reversed when the Valley controller repeated the instruction to turn left 30°. By the time the captain was able to reverse the turn, the aircraft had turned through approximately 20° and closed to 3.7 nm from the RJ. At the time, the aircraft were separated vertically by approximately 800 feet (Appendix A, Figure 1).

6. The crew of the Airbus turned right when a left turn had been directed. This error increased the rate of closure between the Airbus and the Regional Jet.

Figure 1. Loss of separation between the Airbus and the Regional Jet.

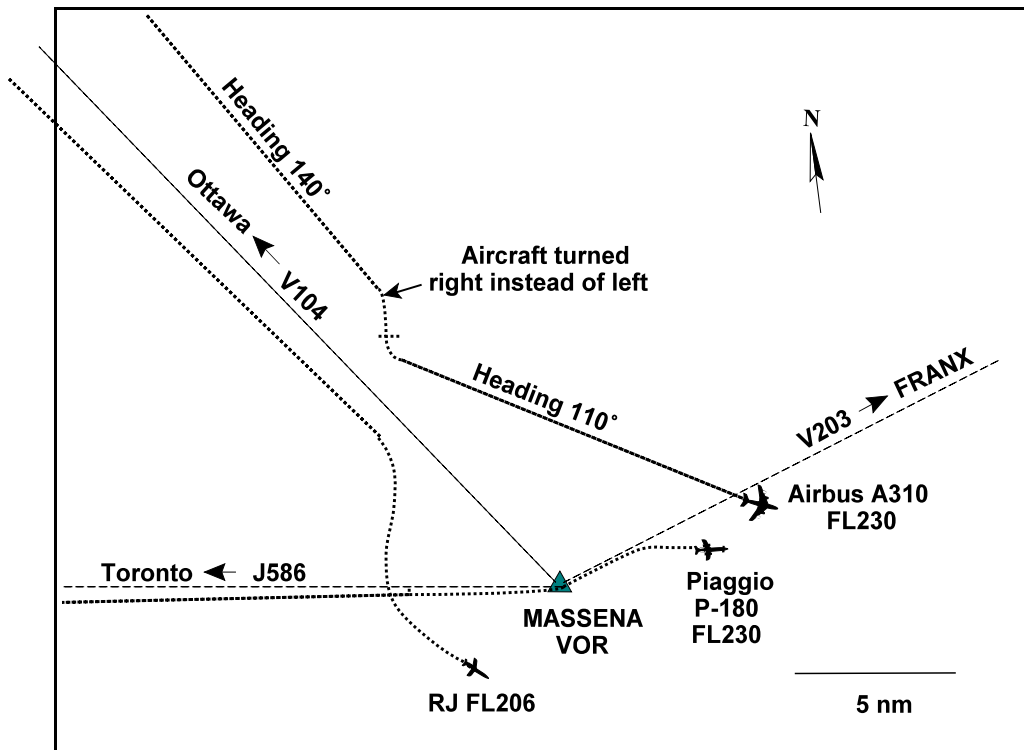
At 1641:25, as the aircraft were approaching the airspace boundary between Montréal ACC and Boston Air Route Traffic Control Center (ARTCC), the OJI initiated handoff communications with the Boston ARTCC controller. After completing the exchange and issuing a clearance to the RJ at 1641:55, he noticed the approaching conflict between the Airbus and a Piaggio P-180. The Airbus was at FL230 on a heading of approximately 115°. The Piaggio P-180 was also at FL230 over the Massena VOR approximately 4 nm south of (to the right of) the Airbus. The OJI issued an instruction to the Airbus to turn right immediately to a heading of 080°. Without waiting for a reply, the OJI then issued an instruction to the Piaggio P-180 to turn right to a heading of 150° immediately. This instruction was followed by a third transmission from the OJI, the first part of which was to the Piaggio P-180 repeating the instruction to turn right to a heading of 150° and continuing without interruption to the Airbus to turn left to a heading of 060°. The crew of the Airbus stayed on their heading of 110°, and the Piaggio P-180 crew turned right. The two aircraft approached to within 3 nm while at the same flight level (Appendix A, Figure 2). The OJI did not issue a safety alert using the phraseology recommended in ATC MANOPS.

The pilot of the Airbus did not see the Piaggio P-180 or notice the aircraft's intruder symbol on the cockpit TCAS display, and the relative geometry of the two aircraft did not meet the requirements for the generation of a traffic alert or a resolution advisory. The pilot of the Piaggio P-180, after receiving further instructions from the OJI to descend, reported that the Airbus was in sight.

2. The OJI did not monitor the traffic in sufficient detail to be aware of the flight level of the Piaggio P-180. As a result, the Airbus was cleared to that same flight level.

Figure 2. Loss of separation between the Airbus and the Piaggio.
